U.S. Department
of Transportation
**Federal Aviation
Administration**

General Aviation Airworthiness Alerts

AC No. 43-16

**ALERT NO. 227
JUNE 1997**

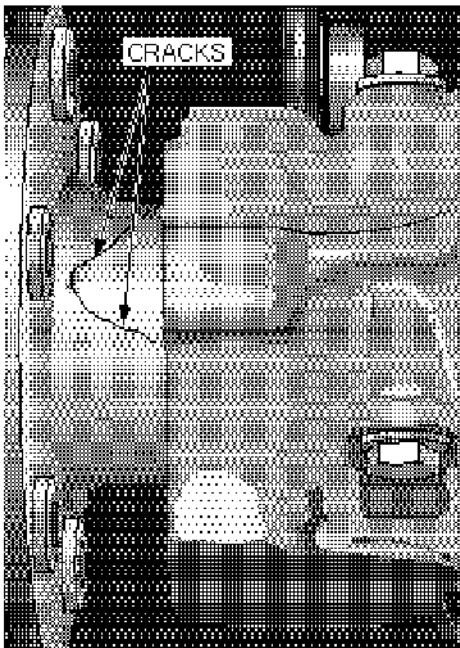
Engine Crankshaft
Cracks
8510

This aircraft was used exclusively for flight training. During a preflight inspection, the student pilot found engine oil residue on the cowling.

Further inspection by maintenance personnel revealed the crankshaft was cracked in two places. The cracks converged at the radius of the crankshaft and the propeller flange. (Refer to the following illustration.) The maintenance record indicates a history of a propeller strike and sudden stoppage. The submitter speculated that when the sudden stoppage incident occurred, this defect had not been detected.

Part total time-1,809 hours.

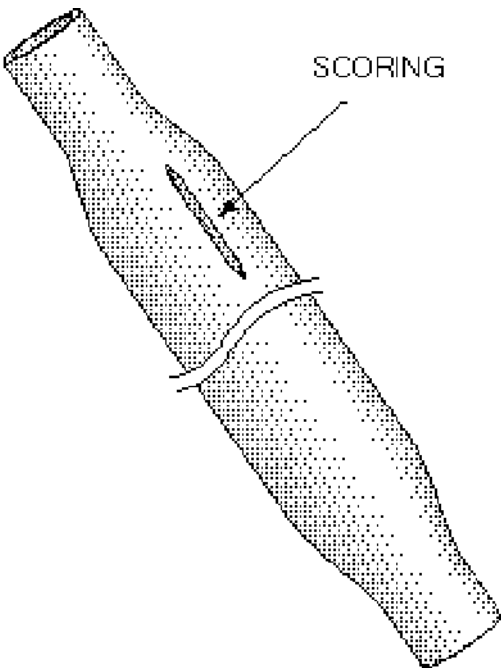
Beech Model 58 Baron	Rudder Linkage Damage 2721
-------------------------------------	---

During an annual inspection, the rudder pedal bellcrank interconnect tube (P/N 002-410034-1) was found damaged.

The tube had been worn completely through its wall thickness (in a longitudinal direction) by a “PK” screw. The damaged area was approximately 1 inch long. (Refer to the following illustration.) The upholstery type “PK” screw was used to secure the “kick plate” to the floor board. The submitter warned that using “PK” screws longer than .75 inch may cause interference with the rudder or other flight control linkage.

Part total time-265 hours.

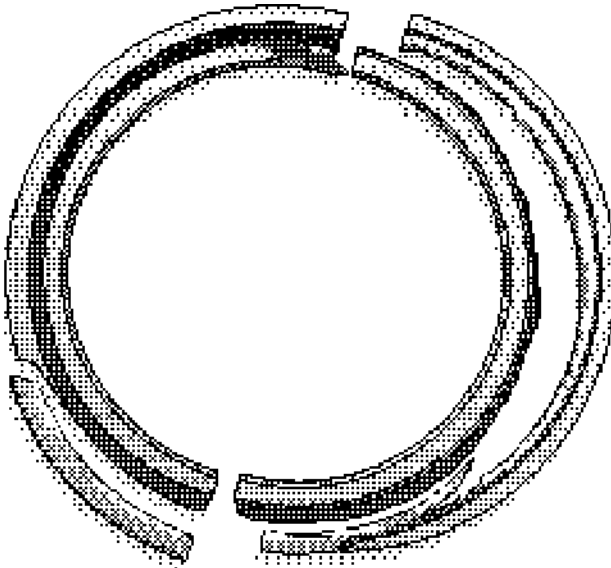
Propeller Blade
Bearing Failure
6111

The left engine propeller was found to be "slinging" grease, and the blades appeared to be "loose." The propeller was a Hartzell, Model HC-E4A-3.

When the propeller was removed and disassembled, the blade bearing race (P/N A2202) was found broken. The bearing race split around approximately half of its diameter, and another (smaller section) broke from the other half. (Refer to the following illustration.) This situation caused a very hazardous condition which could have resulted in a catastrophic failure and an aircraft accident.

Part total time-6,635 hours. Time since overhaul-2,552 hours.

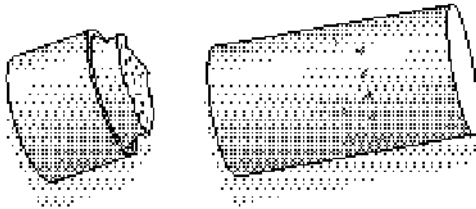
Cessna	Nose Landing Gear
Model T210	Failure
Centurion	3230

During a landing approach, the nose landing gear could not be extended to the "down and locked" position. All attempts to lower the nose gear failed, and a "nose gear up" landing was made.

The aircraft was taken to a hangar and placed on jacks for a test of the system. The landing gear cycled normally through 20 cycles with no apparent problems. The nose gear actuator was removed and sent to the manufacturer for further testing. The manufacturer reported that both of the down lock pins (P/N 9882020-1) in the nose gear actuator bearing end were broken. The pins failed where they were retained by a roll pin. (Refer to the following illustration.) With the actuator lock pins broken, the actuator could not engage the down lock hooks onto the pins. The jamnut on the actuator shaft would not pass to allow the actuator to fully retract. Cessna has issued Service Bulletin (SEB) 95-20 which covers this subject and provides inspection criteria. Owners, operators, and maintenance technicians are urged to comply with this SEB at the earliest opportunity.

Part total time-1,993 hours.

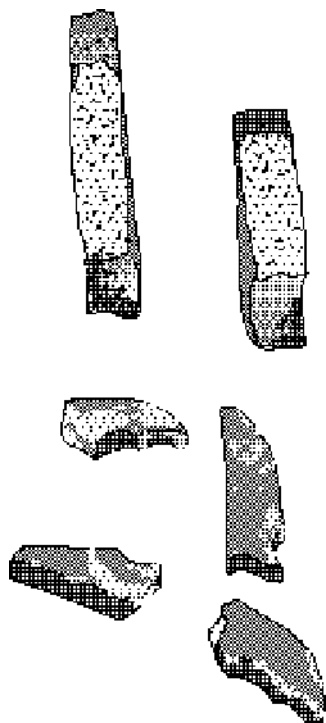
Cessna Model 320F Skynight **Nose Landing Gear Failure 3230**

When the landing gear was selected to the "up" position after takeoff, the nose gear failed to retract and would not extend.

An investigation disclosed that the nose gear bellcrank (P/N 0842102-2) had broken during the attempted retraction cycle. According to the aircraft maintenance records the nose gear failed in the same manner approximately 9 years ago. The bellcrank was broken at the point where it attaches to the main drive tube. (Refer to the following illustrations.) An inspection of the broken bellcrank parts indicated it failed "instantaneously," the attachment bolt was pulled through the mounting hole in the bellcrank, and the attachment bolt was severely bent.

The FAA Service Difficulty Program data base contains 61 other reported failures of this part. The submitter speculated the part may not be structurally adequate for long term service. This report and supporting data has been forwarded to the responsible FAA aircraft certification office for appropriate action. A Safety Recommendation will be initiated.

Part total time-665 hours.

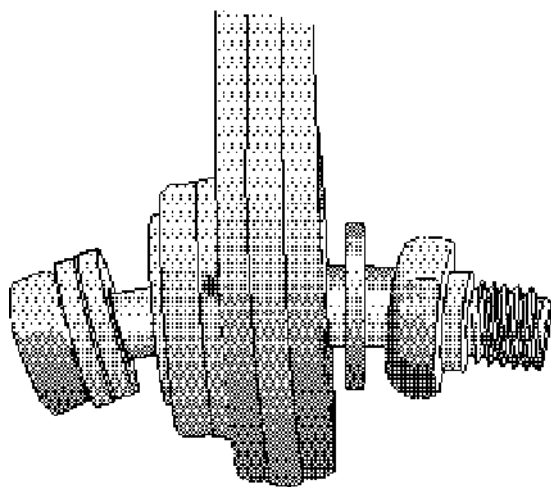
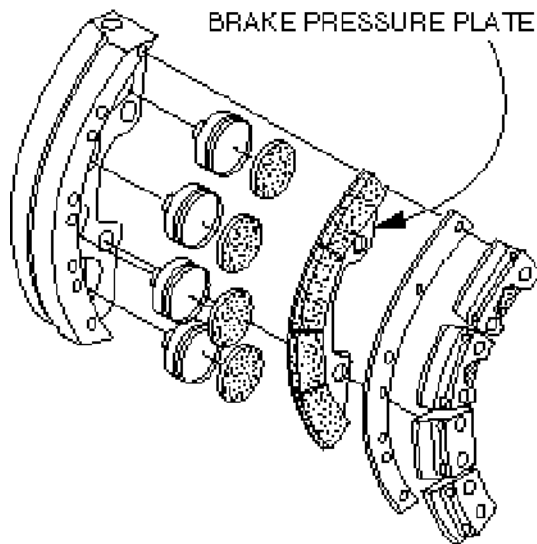
**Improper Wheel
Brake Installation
3242**

improperly installed. This caused the brake lining to face the piston housing instead of the pressure plate which allowed “metal to metal” contact when brake pressure was applied. There was evidence that extremely high temperatures had been produced by braking action. The pressure plate and the linings were damaged beyond acceptable limits and were replaced. (Refer to the following illustration.)

An investigation revealed the pressure plate had been installed improperly during replacement of the brake linings. The brake linings had been changed, in conjunction with a phase inspection, 9 days prior to the discovery. The submitter stated that mechanics should be aware that the pressure plate can be installed backwards, and the proper technical data should always be consulted.

Aircraft total time-525 hours. Part total time not reported.

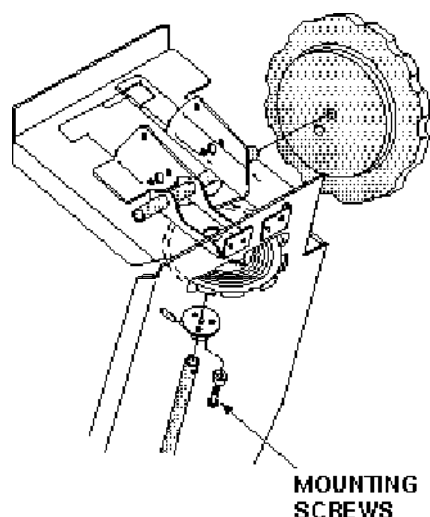
Piper	Rudder Trim System
Model PA 46-350P	Failure
Malibu Mirage	2721

An inspection revealed that the three mounting screws, used to hold the rudder trim control wheel to the sprocket, had loosened and fallen to the floor. This allowed the rudder trim wheel to spin freely without producing a corresponding movement of the rudder trim tab. (Refer to the following illustration.) The submitter stated: "The manufacturer should issue a service bulletin allowing these screws to be replaced with machine screws and possibly a safety device to keep them in place."

Part total time-308 hours.

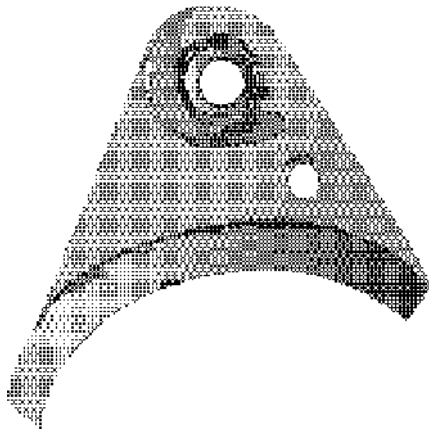
The bushing for the pitch link does not fit flush on the back side of the grip ear. This causes the single steel washer (under the nut of the pitch control link bolt) to be unsupported over the recess; therefore, it can bend and allow the bolt to lose torque. (Refer to the following illustration.) The pitch control came in contact with the grip ear as the loose bolt was able to move. The submitter stated that he had seen this problem several times in the past. The submitter has submitted several Malfunction Or Defect Reports on this problem and has also contacted the manufacturer, but has had "no results." The submitter suggested that either double stainless washers should be used or a bushing of the correct length should be manufactured.

Part total time-1,143 hours.

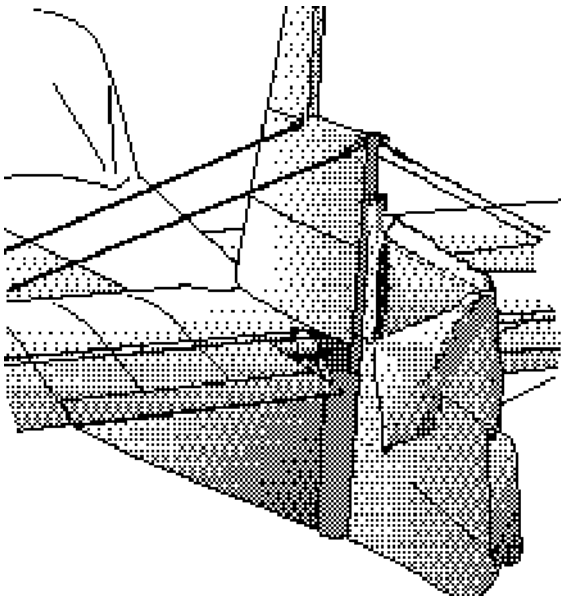
Rudder Hinge Failure
5540

An investigation disclosed that the top rudder hinge (new type triple design P/N 54030-987) failed. This was followed by structural overload of the tubular spar and separation of the upper section of the rudder. (Refer to the following illustration.) The point of separation was approximately 6 inches below the upper rudder hinge. In accordance with Airworthiness Directive (AD) 79-10-10, a new rudder with a "triple hinge" was installed. The submitter suggested the rudder and the hinges be inspected every 25 hours of operation.

Part total time-857 hours.

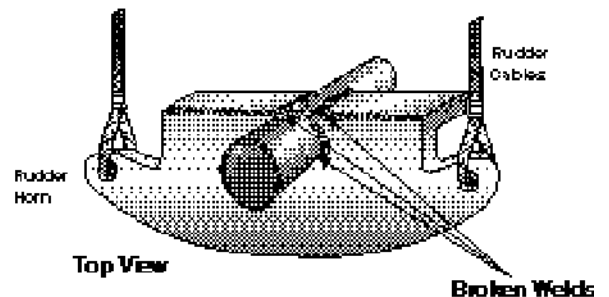
has been covered, it is impossible to inspect. There were corrosion products in some of the broken welds; therefore, the submitter stated the weld failed over a long period.

Part total time-420 hours.

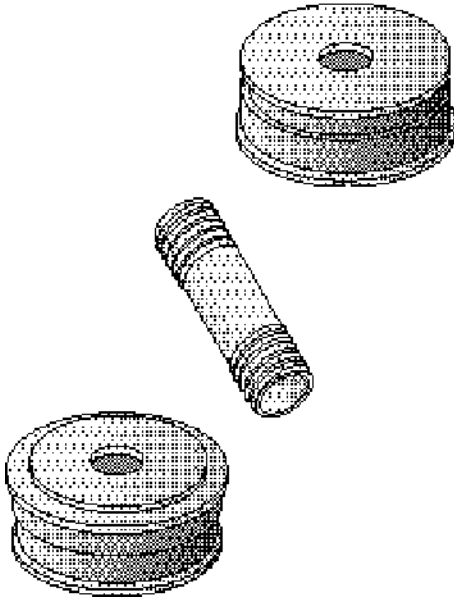
Amateur-Built Aircraft With An O-360 Lycoming Engine

increased engine vibration to an excessively high amount. The submitter stated that builders should be encouraged to install parts as per the manufacturer's instructions.

Part total time not reported.
